Saline River Dam

Common Misconceptions

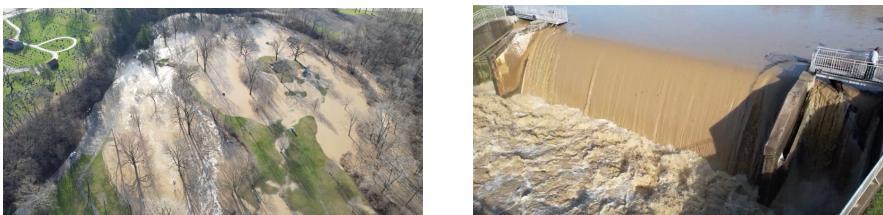
The Saline River Dam was not built for flood control, as such, it does little in the way of flood attenuation. Preliminary hydraulic modeling completed as part of this study indicate that removal of the dam would have negligible impacts to the water surface elevation downstream, even following runoff events. Although removal of the dam does eliminate the impoundments, storage is gained by shaping floodplain shelf as part of river restoration efforts.

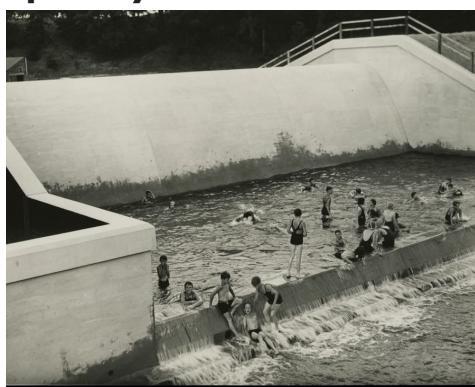
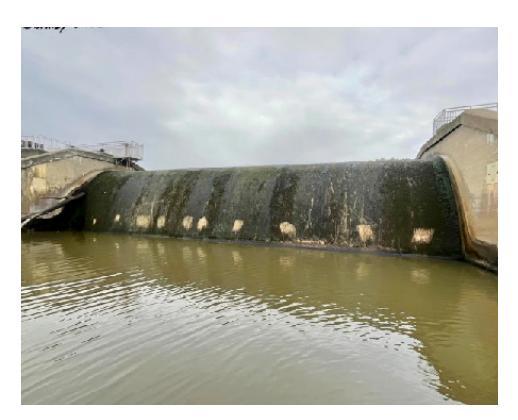
Spillway

The dam spillway was constructed in 1935. A picture of the new spillway from the year it was constructed is shown on the left. The picture on the right was taken in 2021 as part of the recent structural inspection.

As outlined in the 2021 structural report, the concrete is deteriorating and needs repairs.

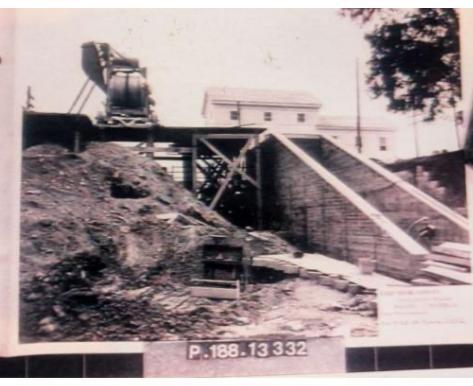
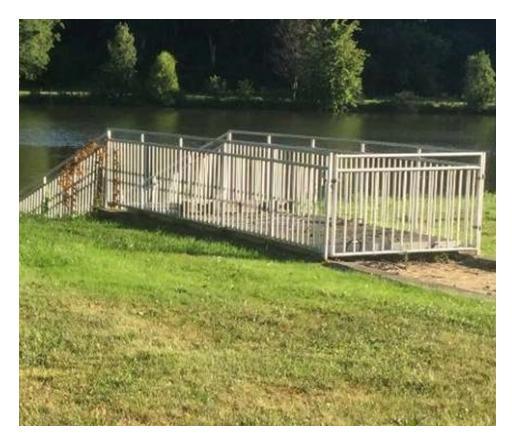
Mill Race

Figure 9: Millrace Inlet Structure During Construction. Photo courtesy of Wendy Weller.

The mill race was constructed in 1935 and historically routed water under Michigan Avenue to turn a turbine at the mill to produce electricity.

A picture of the mill race while under its initial construction is shown on the left. On the right is a photo of the existing safety railing at the top of the mill race on the south west portion of Mill Pond Park.

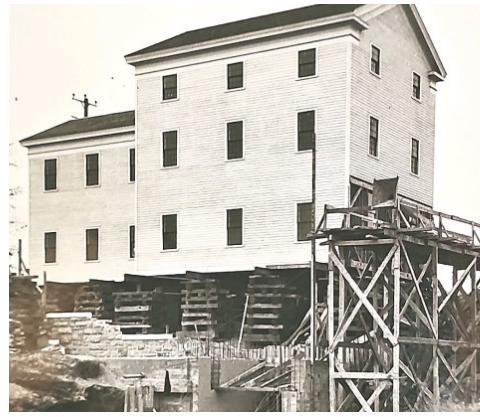
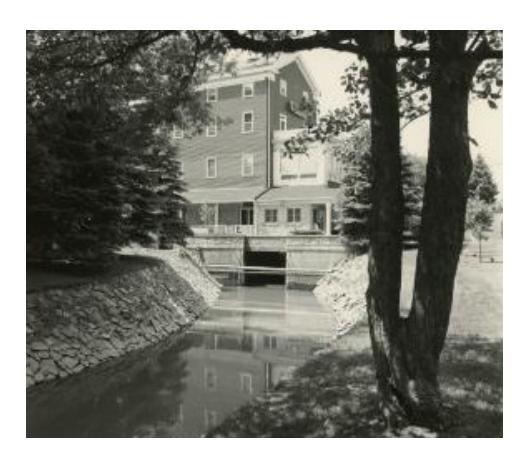
Mill & Tail Race

The photo on the right shows the tail race downstream of the historic turbine and mill. The photo on the left shows construction of the turbine over the mill race at Wellers in the 1930s.

Dam removal could result in removal of the tail race also. The City is looking at options to keep the tail race functioning should the dam be removed. The tail race currently feeds a stream of water through the Wellers property.
